Outdoor Exposure Results for Pretreated and Topcoated Aluminum Armor Alloys 2519, 5083, and 7039

ARL-TR-3283

September 2004

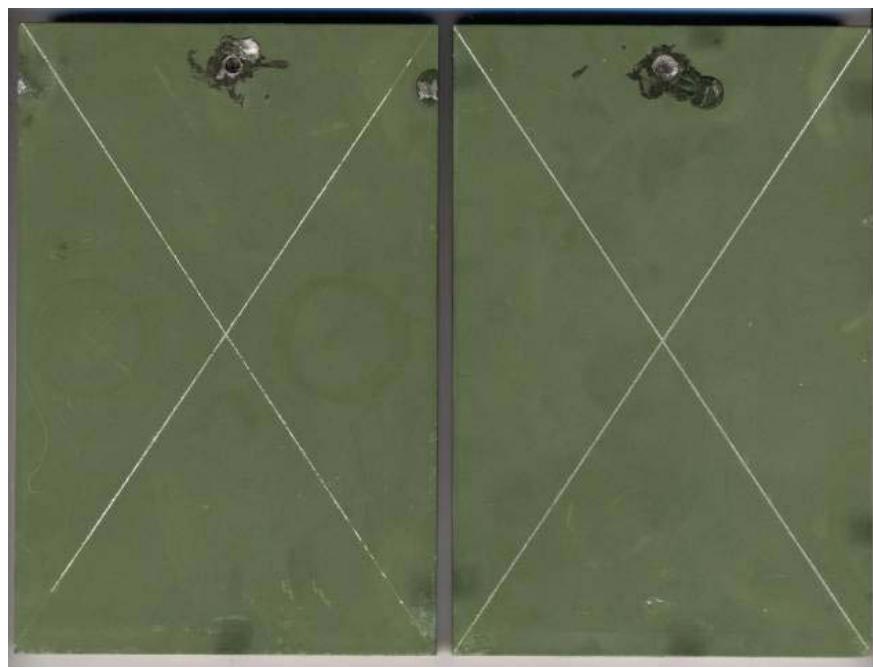
Figure 8. Grit-blasted 2519 after 48 months of exposure.

Accelerated corrosion testing proved to be disastrous for nonchromate conversion coatings on 2519. Total failure was seen on 2519 with all but three surface treatments—grit blasted, chromate, and Chemcote, with chromate performing best. However, as mentioned earlier, the 2519 samples performed much more admirably in outdoor exposure, with the biggest apparent surprise being the grit-blasted 2519 samples with no pretreatment. Although unexpected, the impressive performance of the grit-blasted 2519 panels was not in conflict with the accelerated
